Oil Analysis Identifies Source of Water in Dozer Power Shift Transmission

This case study illustrates how oil analysis determined the most likely source of excessive water contamination in a crawler dozer power transmission to be the result of improper storage and handling of the new lubricant supply.

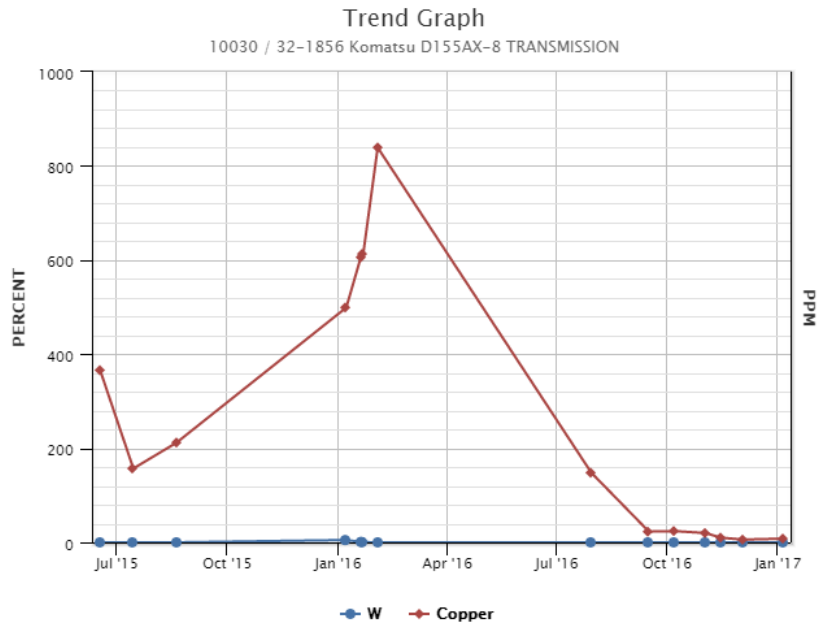
Figure 1

The only other typical explanation would be the improper handling and/or storage of a new oil supply. The new oil could have been delivered via a contaminated oil tote, lube truck tank or drum. Improper storage and handling of the new lubricant supply after delivery may have also resulted in contamination from the environment.

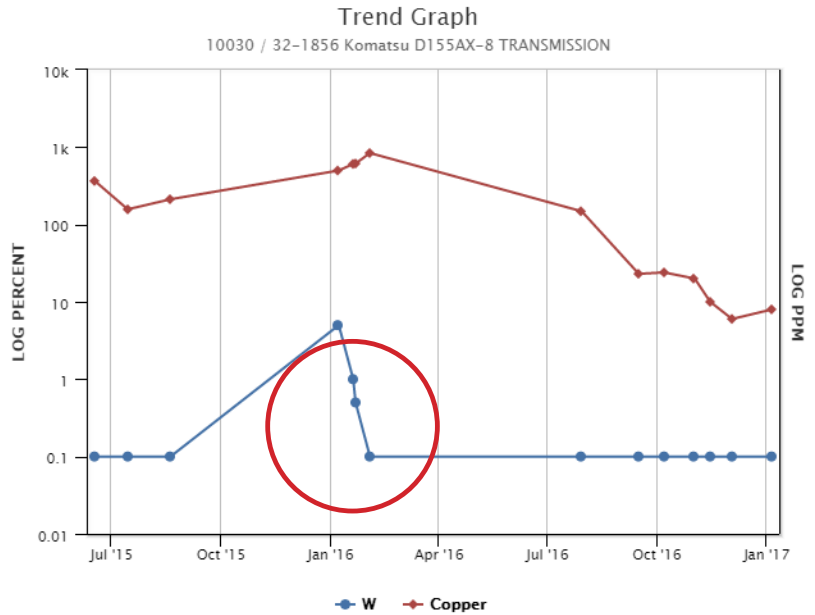
Figure 2

After reassembly of the radiator, and the transmission oil and oil filters were changed, another oil sample was taken within 33 operating hours. The water content had decreased to 1% by volume. The oil and filters were changed again and allowed to accumulate 1 hour of operation before sampling again. The water content was reduced to 0.5% by volume. The oil and filters were changed once again and allowed to run in service for 183 hours before sampling again. The third oil change water result was less than 0.1% by volume.
