Oil Condition Monitoring Case Study

SILVER LINING IN PLANTS OIL ANALYSIS PROGRAM PREVENTS CATASTROPHIC GENERATOR FAILURE

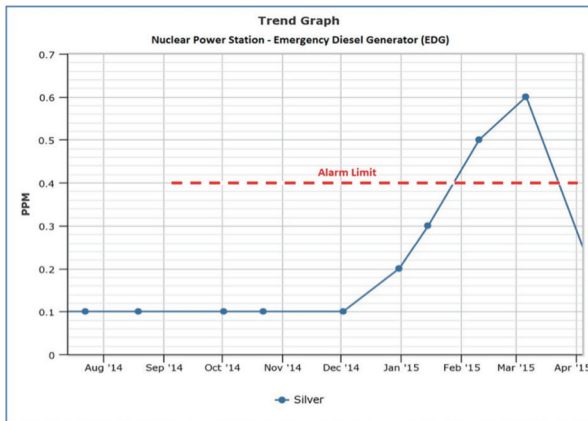
In January of 2015, the silver content from EMD #1 increased from 0.1 ppm to 0.2 ppm. A laboratory data analyst contacted plant personnel to report the increase and discuss the situation. It was decided to halve the sampling frequency for this unit. Subsequent samples showed a steady increase in the reported silver, peaking at 0.6 ppm.

Figure 1: Trend Graph of Silver Concentration in Oil Samples

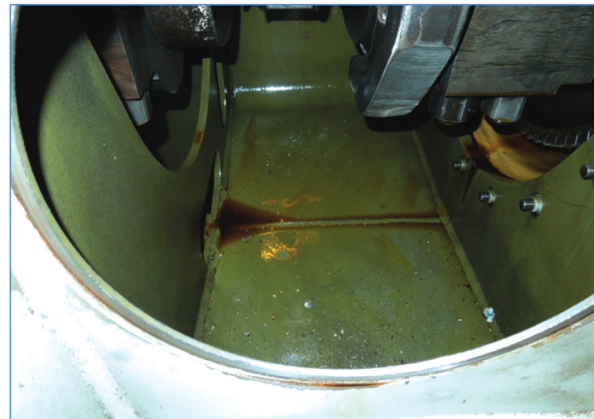
Operating experience was reviewed at the plant and two sister plants that had experienced similar circumstances. An inspection was performed, and silver coated bearing material was identified in the EMD engine crankcase sump below the affected powerpack.

Figure 2: Silver-coated bearing material identified in the engine crankcase.

Following plant procedures, a shutdown of the engine was initiated. Further examination revealed component damage. The silver had been displaced from the wristpin bearing surfaces to the carrier bearing surfaces blocking one of the lubricating oil channels.

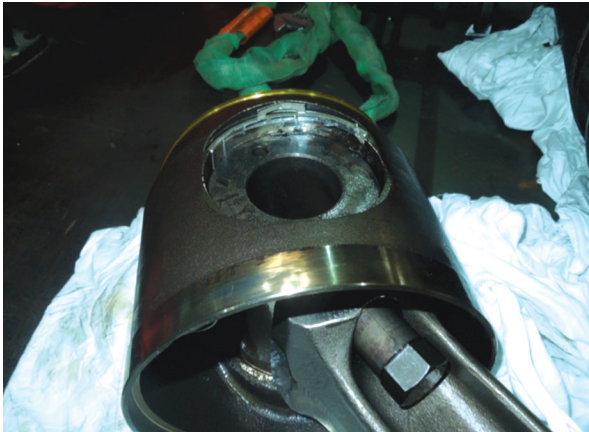
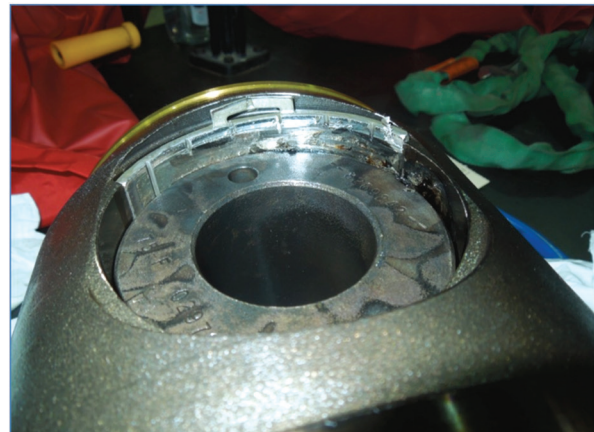
The partially blocked oil channel prevented normal oil flow at the bearing-to-wristpin interface. There also would have been base metal-to-base metal contact which would have led to catastrophic bearing failure and critical engine damage (**See Figures 3 & 4**).

The plant conducted a root cause analysis in coordination with the equipment manufacturer. The findings indicated the wear was initiated by repeated engine starts under marginal lubrication conditions. The silver and lead bearing material is displaced into the oil channels of the wristpin bearing, limiting or preventing lubricant flow across the full surface of the bearing. When the channels are substantially or completely blocked, the bearing material wears away until the steel wristpin contacts the steel bearing shell and the bearing fails.

Figure 3: Silver wrist pin bearing was damaged.

Figure 4: Silver wrist pin bearing was damaged.

If Bureau Veritas' testing had not identified the onset of the wear and if the plant personnel had not reacted appropriately, the unit would have failed. Because the accelerated wear was identified and acted upon early, only minor repairs were required at a cost of \$12,000.
