Oil Condition Monitoring Case Study

OIL ANALYSIS PROVIDES INFORMATION VITAL TO DETERMINING ROOT CAUSE OF WATER CONTAMINATION IN INDUSTRIAL GEARBOXES

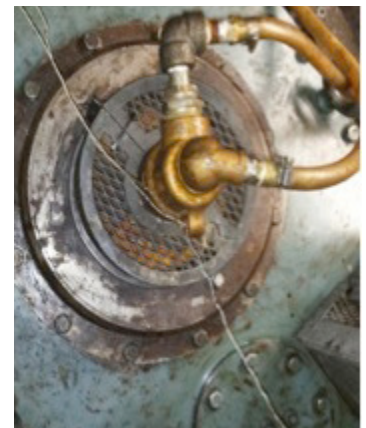
Figure 1 – Top view of the Autoclave gearbox showing the water supply to the rotary joint

In both cases, the water leak was traced to a loose hose fitting on a rotary joint that directs cooling water down the hollow mixer shaft. The more obvious leak in gearbox #4 was corrected early while the leak in gearbox #1 was just a slight drip making it more difficult to identify. Sampling done April 30, 2015, revealed that the lubricant in both gearboxes was free of water.

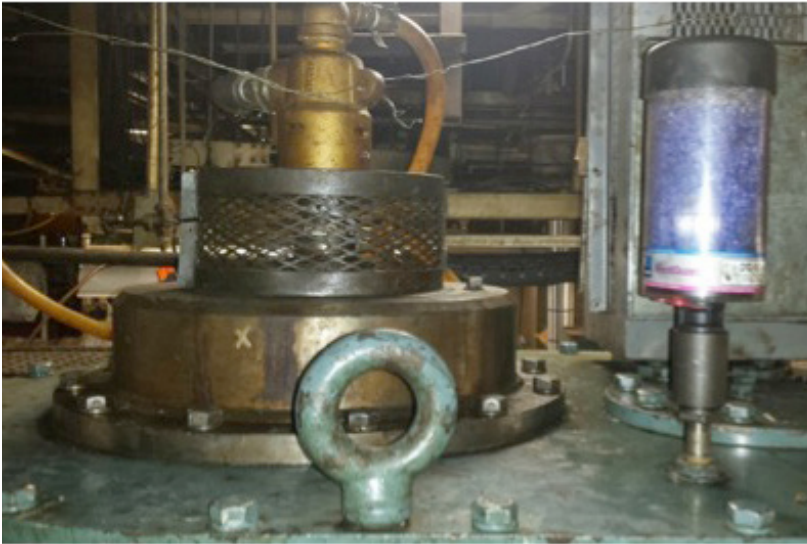
Figure 2 - Side view of the Autoclave gearbox rotary joint

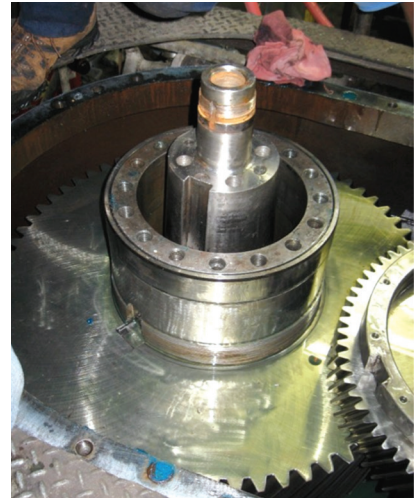
Figure 3 - Autoclave bearing and shaft cap removed revealing the underlying gearing. Cooling water is directed down the hollow center portion of the shaft

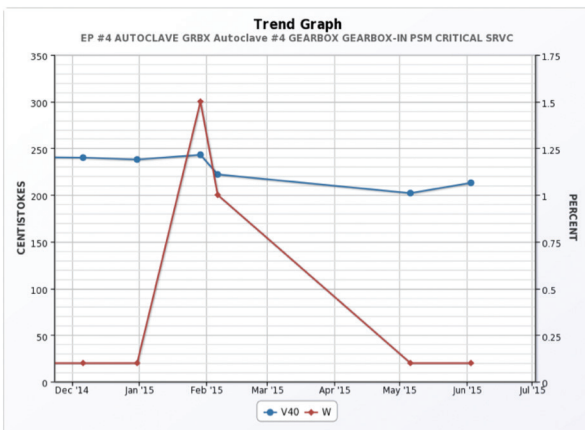
On January 22, 2015, routine monthly sampling of Autoclave gearbox #4 identified 1.5% water in an emulsion. Until this sample, the gearbox had no history of water present in the lubricant. Based on the significant level of water present and taking into consideration the criticality of the component to plant operations, the laboratory recommendation was to change the oil, investigate to determine the source of water ingress and resample to confirm that the maintenance recommended improved lubricant condition.

Figure 4 - LOAMSSM Trend Graph illustrating the water concentration present in the lubricant sample of gearbox #4

A leak was discovered and repaired in the water inlet located on the top of the gearbox #4. Eighteen gallons of lubricant were drained from the component and replaced. Maintenance personnel then confirmed that component operation was noise-free, the lubricant supply was contaminant-free, bright and clear and that it had been stored properly prior to use. However, a second sample, drawn on February 4, 2015, again confirmed excessive water in the lubricant in the 1 percent range.

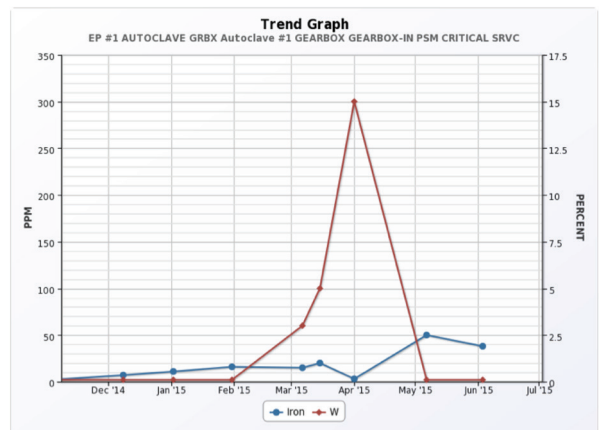
On February 27, 2015, a sample from Autoclave gearbox #4 revealed no water in the lubricant sample while a sample from Autoclave gearbox #1 showed water content 3 percent in an emulsion. The oil was changed and sampled again on March 11, 2015, to reveal an increase of 5% water in an emulsion. By March 25, 2015, the water content had increased to 15 percent in an emulsion. **See Figures 1-5.**

Figure 5 - LOAMSSM Trend Graph illustrating the water concentration present in the lubricant sample of gearbox #1

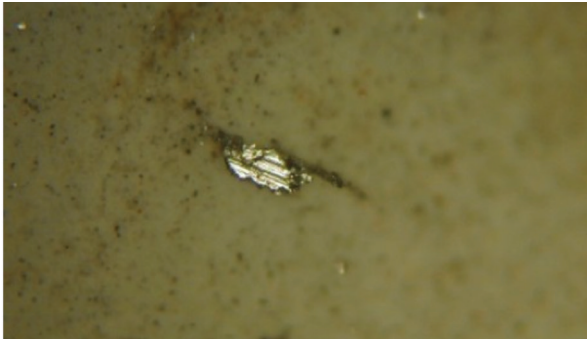
A MicroPatch test was performed to determine the source the water ingress by identifying any unusual wear occurring or the presence of debris or contamination. An examination of the debris present did reveal that a degree of abnormal wear was occurring although there were no visual indications of any possible sources of water. **See Figures 6-7.**

Figure 6 - 150 micron ferrous fatigue chunk

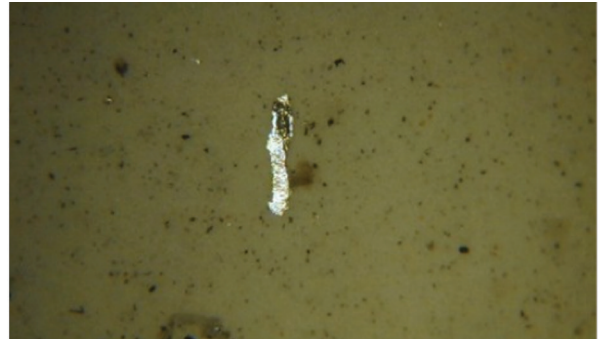
Figure 7 - 160 micron ferrous sliding wear particle
